**LAKE WINNEBAGO DAM**

**CASS COUNTY, MISSOURI**

**MO 20312**

## **PHASE 1 INSPECTION REPORT NATIONAL DAM SAFETY INSPECTION**

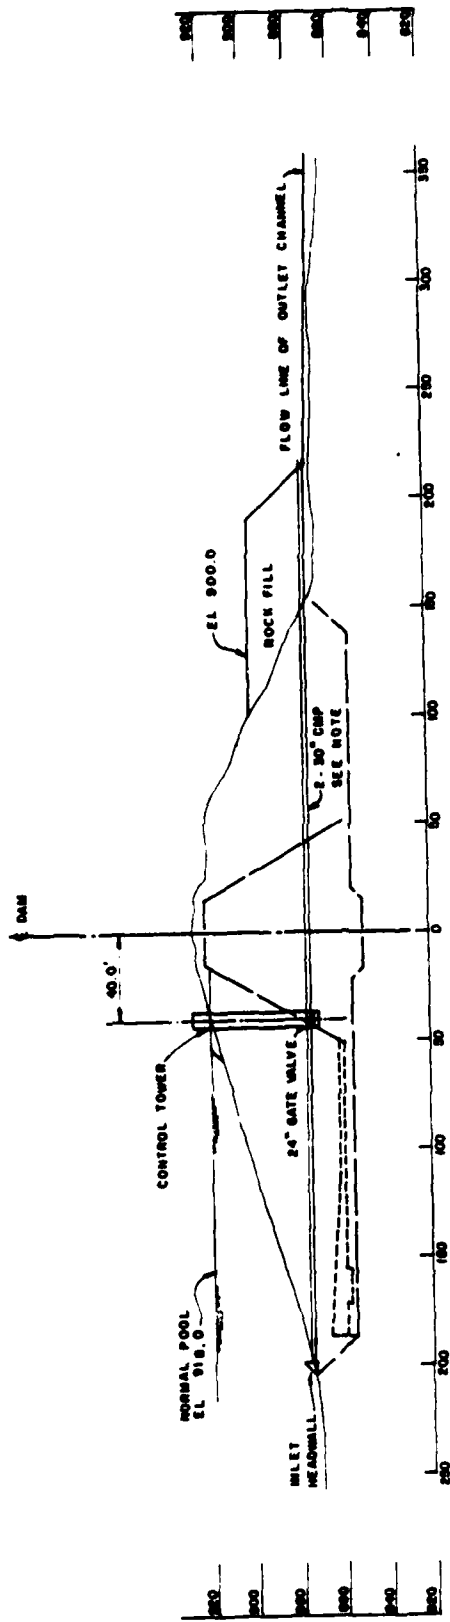
# LAKE WINNEBAGO OUTLET WORKS SECTION

NOTES WEST PIPE GROUTED FULL  
 2. 24" STEEL LINER PIPE PLACED  
 INSIDE EAST PIPE. GROUT BETWEEN  
 LINER AND 30" CMP.
